KRX Hifonics Head Unit Replacement

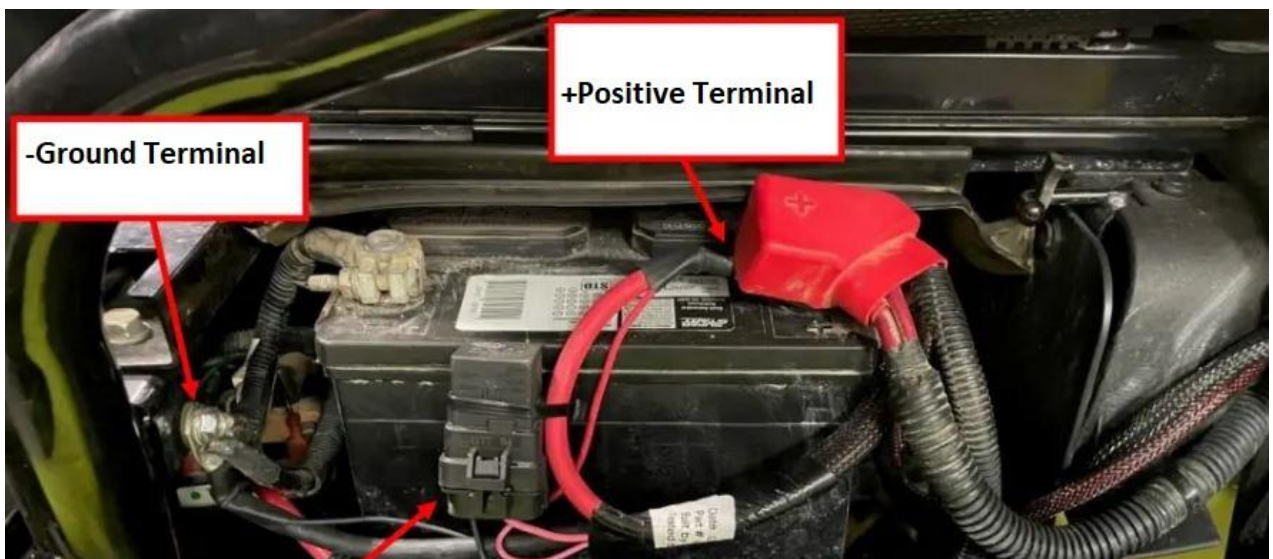
- Once cover is removed, using the adjustable wrench loosen up and take off the red positive cable to disconnect 12V battery supply.

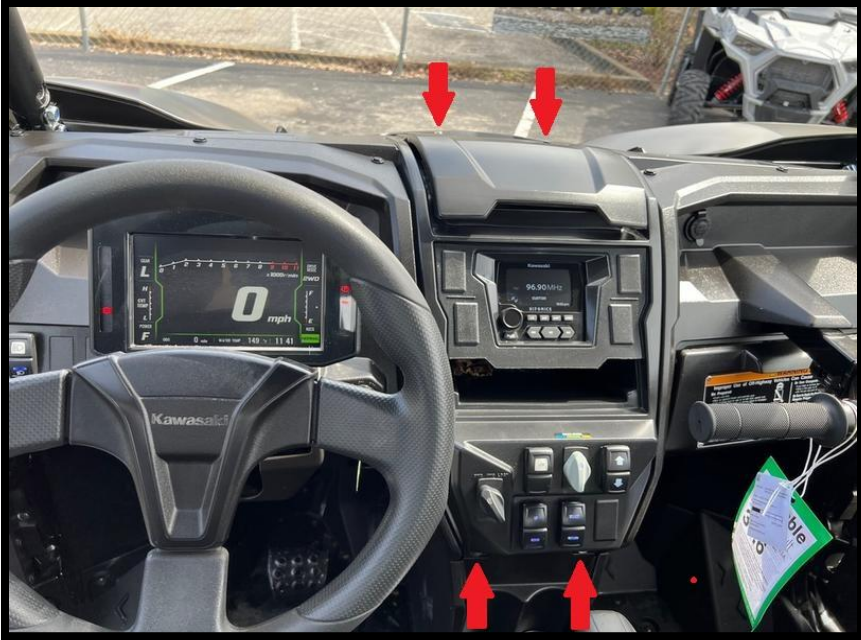
- Remove all 4 push pins and both lower bolt screws

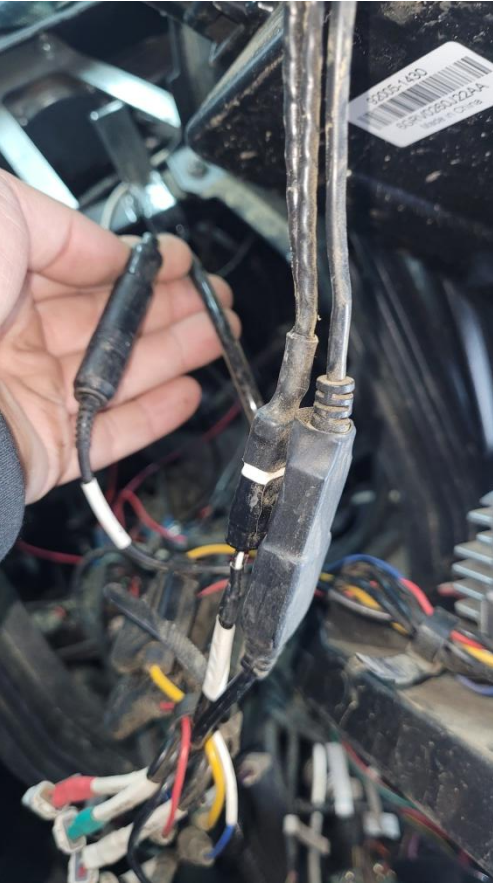
- Once removed pull center of dash to you

- Unplug all the connections from the back of the head unit

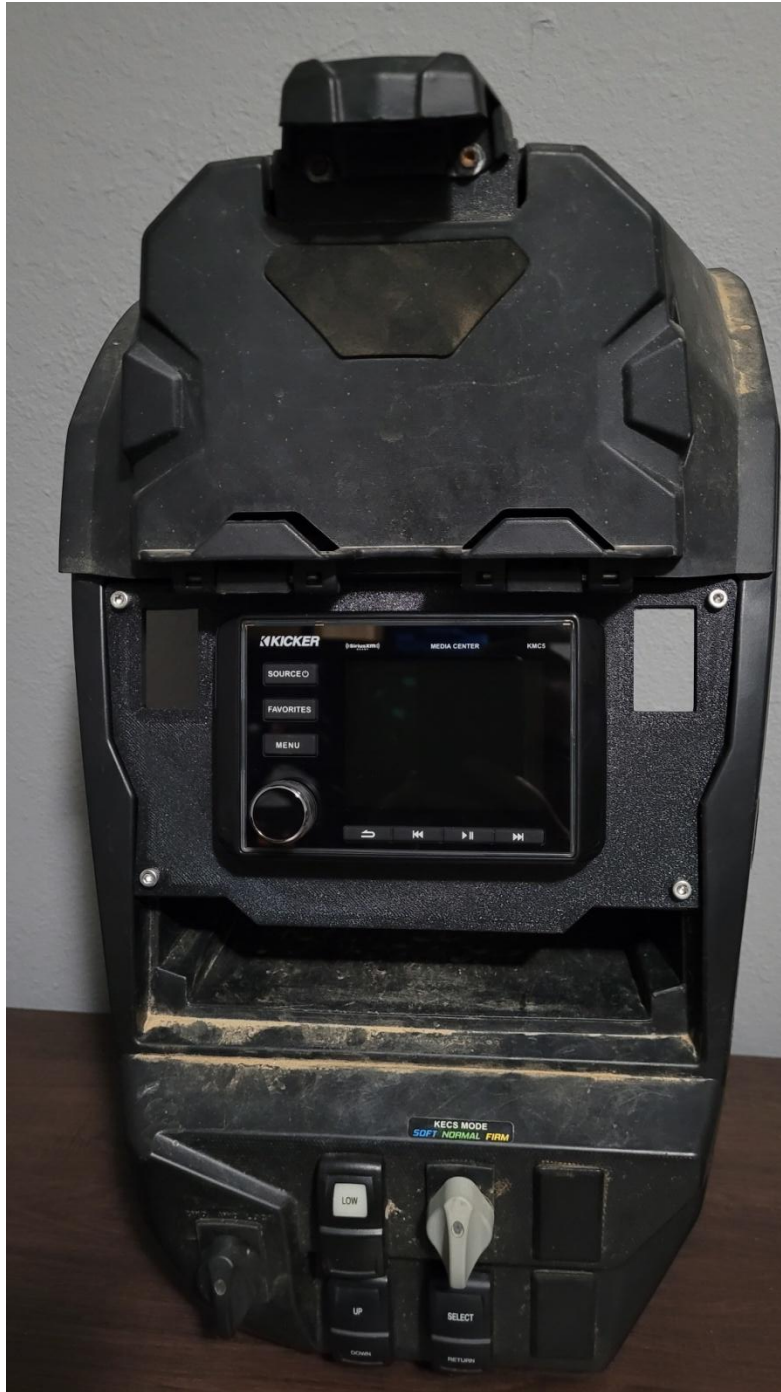
- Line up dash plate over top of stock center dash piece, pre-drill holes and use provided bolts to mount plate to dash piece.
- Set head unit onto dash plate and mark mounting holes, move head unit to pre-drill holes. Then use proved screws to mount head unit to dash plate.
